Maintenance and renewal of permeable paving assets

City of Charles Sturt

History of permeable paving in CCS

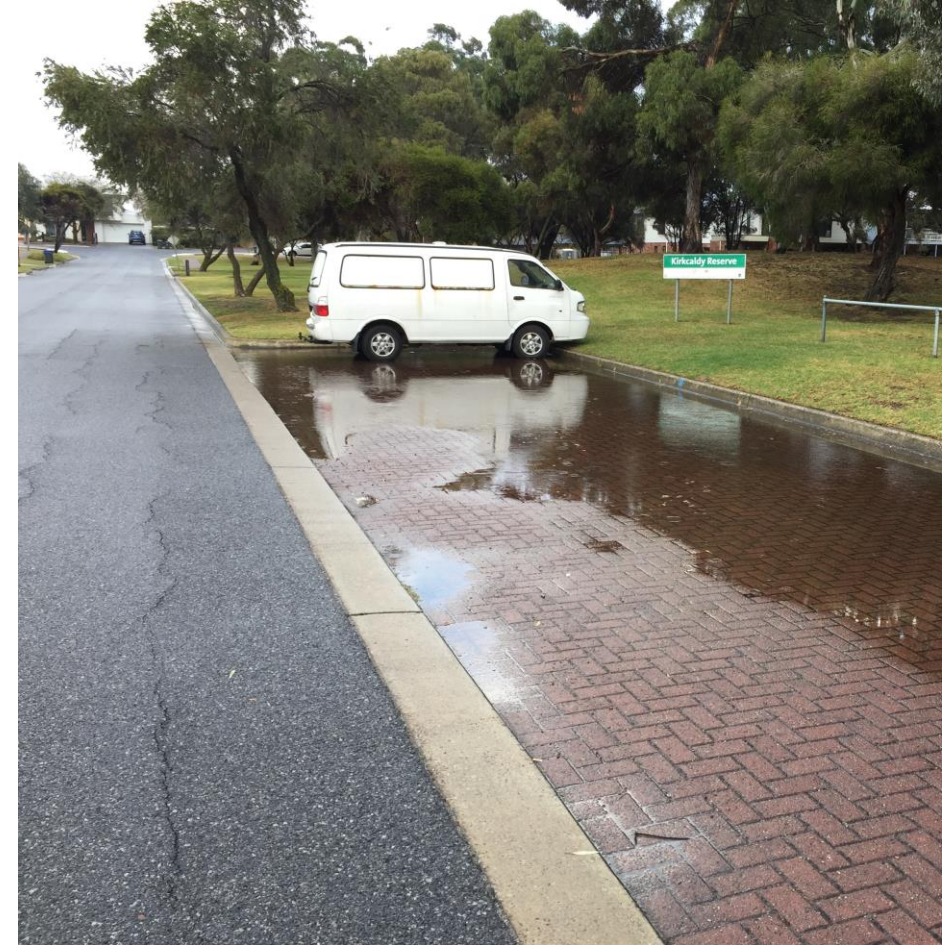
Kirkcaldy Avenue Parking Bays

- Swept 5 times a year
- Issues
 - Some decrease in performance – water holds then slowly soaks away
 - Serviceability issue with the ponding water – no complaints received
- Remedial action
 - High pressure clean – Approximately \$1000
- Continue to monitor as no significant impact

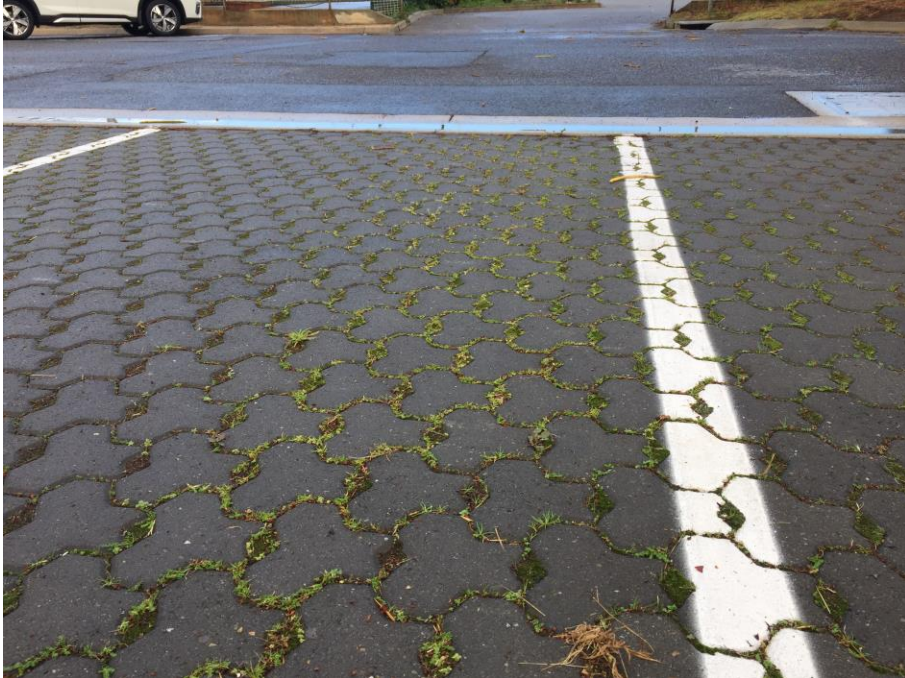
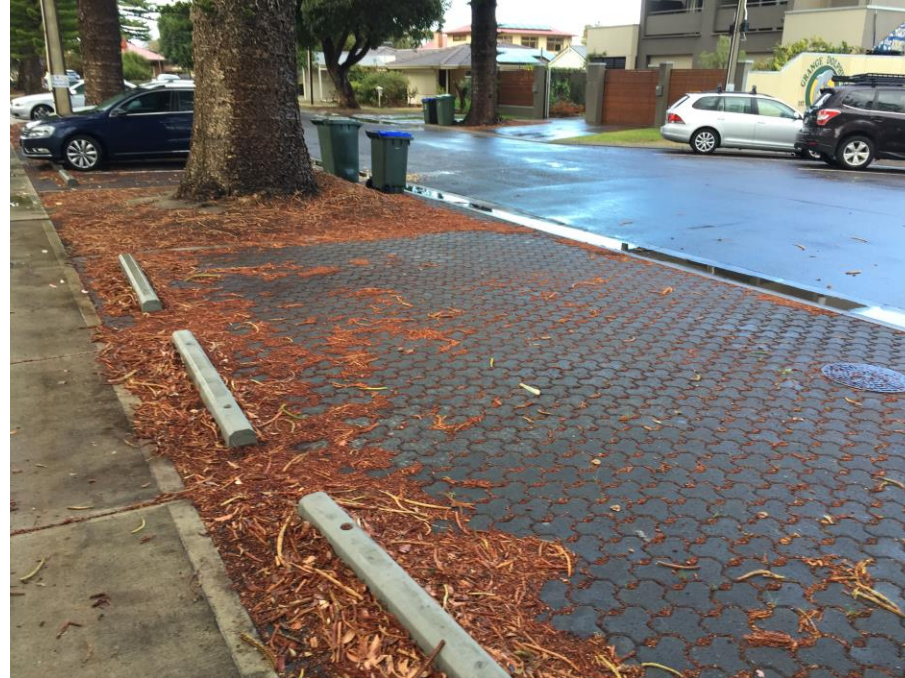
Wilson Court Parking Bays

- Swept 5 times a year with additional reactive cleaning as requested
- Issues
 - difficult to do a thorough clean due to high carpark use
 - moss & pine needles blocking gaps

- Remedial action
 - High pressure clean – 2 days labour – approx. \$2000
 - Added to our “carpark” mini-sweeping program (should have been from the start) – no operational asset handover
- Further actions
 - Continue to monitor
 - May need some refurbishment (lift & relay of small sections)

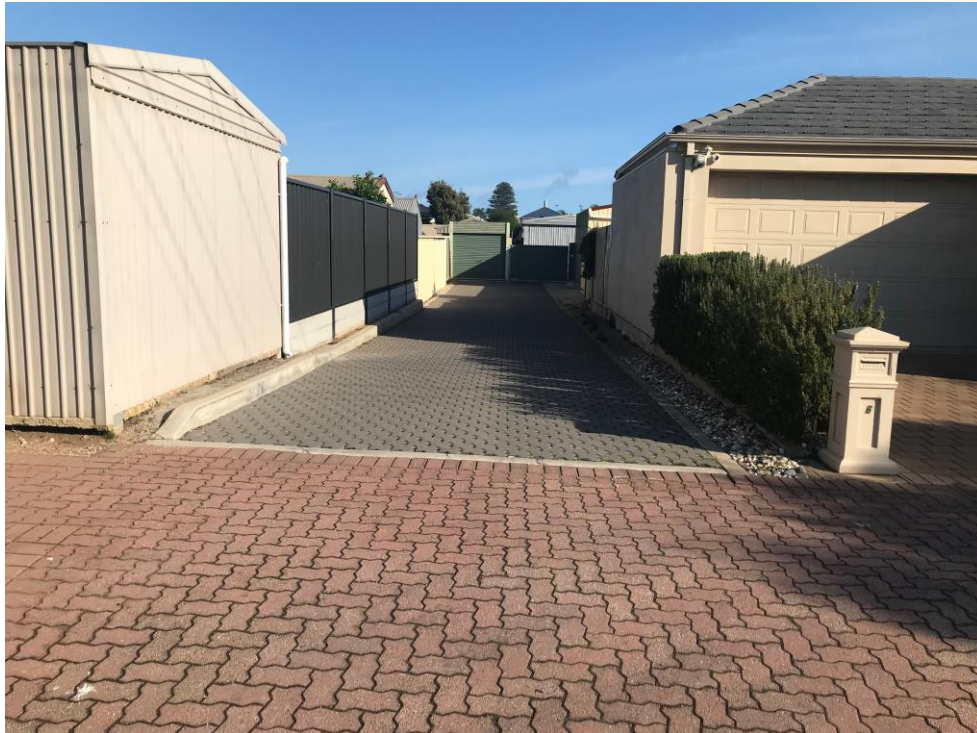
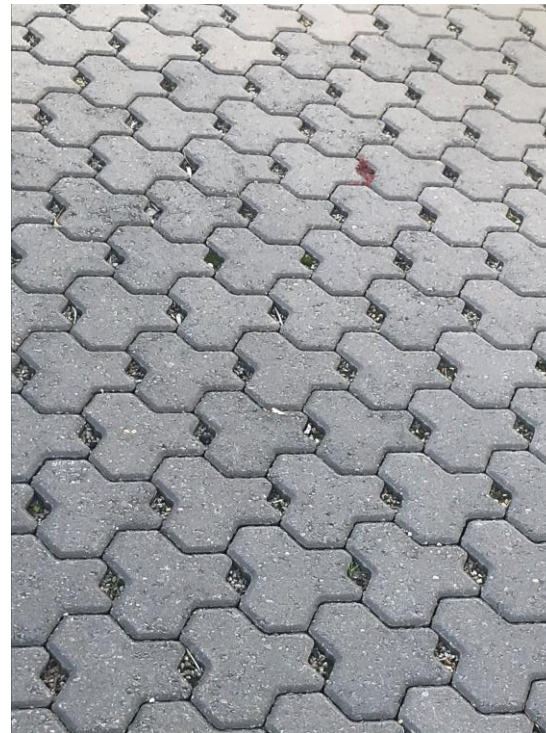
Duke Lane, Semaphore Park

- Currently not maintained
- No reported issues
- Remedial action – added to sweeper program

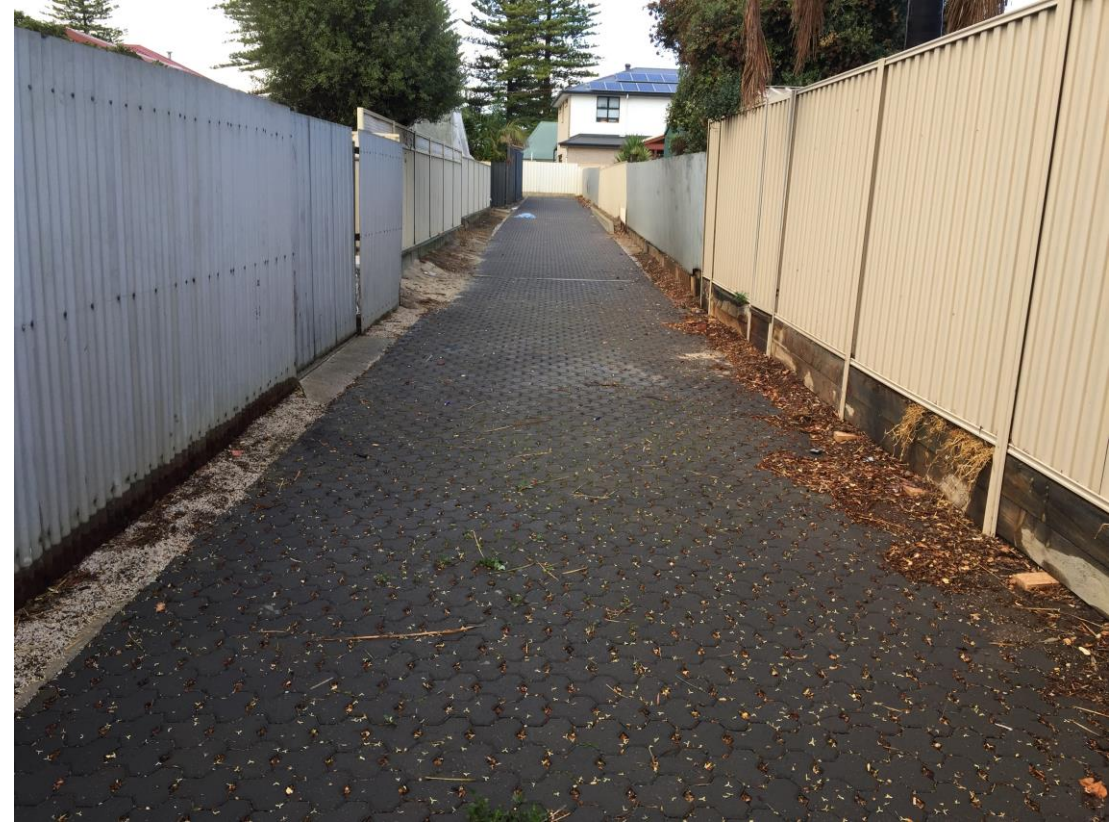
Lane 30 (Anthony St Lane)

- Swept every 6 months
- Resident complaint - mid 2018
 - water not draining due to tree debris and moss blocking gaps
 - ponding significantly and entering property
- Investigation after a rain event confirmed the issue was the gap between pavers was blocked

- Remedial action
- Lift and relay 80m² pavers at low point including replacement of the top geofabric and surface screenings – undertaken in late 2018/early 2019
- Some branches from overhanging tree were also trimmed (tree has since been removed by owner)
- Cost – \$8000
- Continue to monitor after rain events

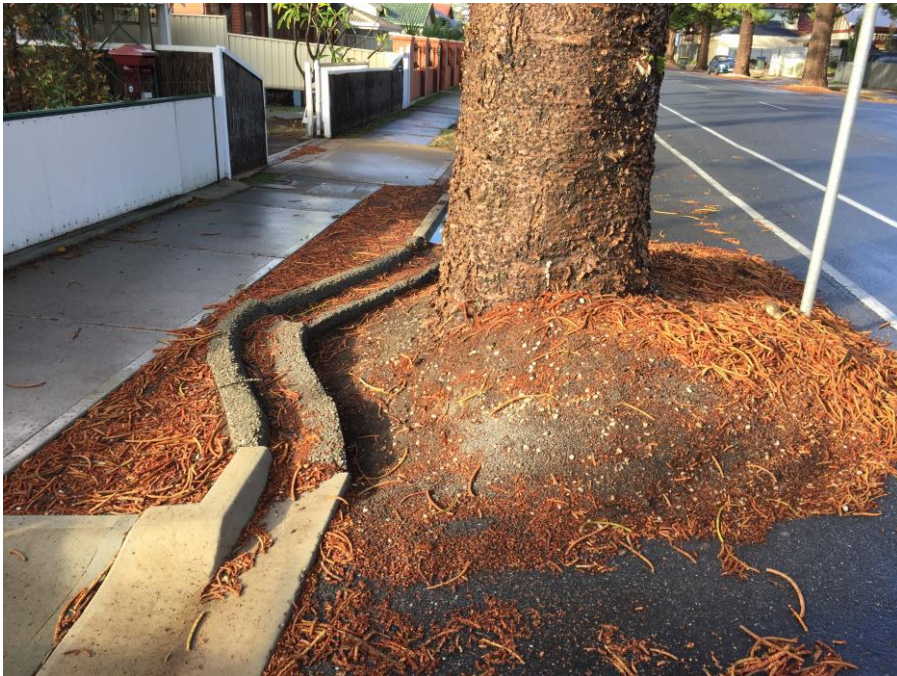
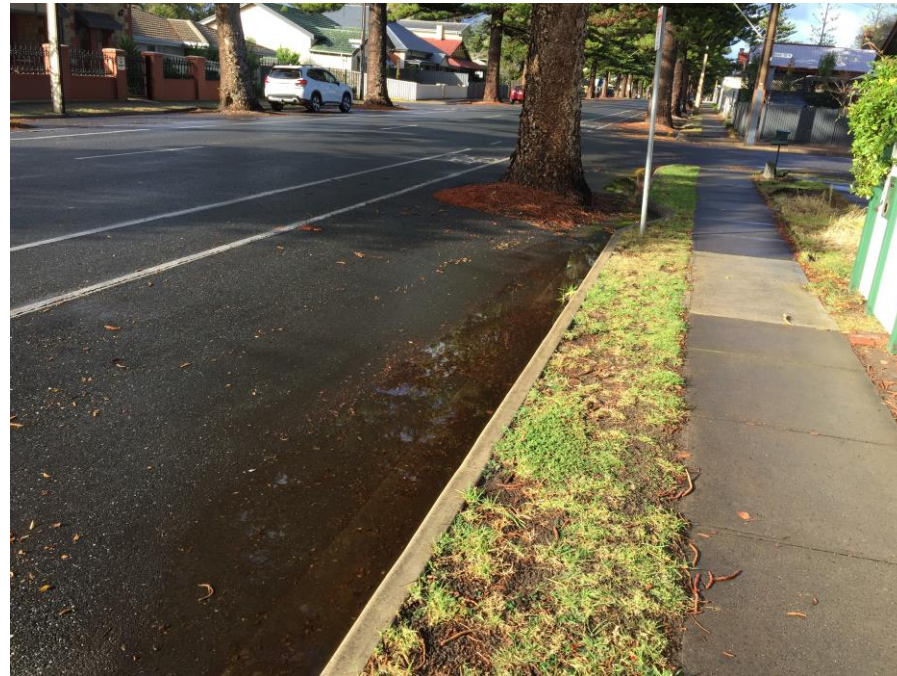
East Terrace

- Swept 5 times a year & high leaf area reactive
- Issues
 - permeable kerb gets blocked due to fine leaf litter
 - leaf litter and lifted sections prevents water reaching the permeable kerb

- Remedial actions
 - high pressure clean
 - 1 days labour – approx. \$1000 work
- Further action
 - 21/22FY - Replace lifted sections and undertake trial to extend permeable kerb to length of parking bays
 - Expected cost - \$10000
