Detention Swale at Goldenfields Reserve

WATER SENSITIVE URBAN DESIGN SYSTEM

Ornamental detention swale

Case study prepared by the City of Tea Tree Gully, Parks Assets Department, February 2010

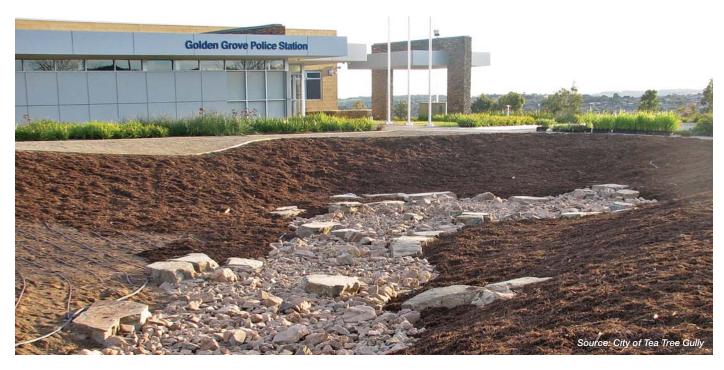
Completed swale and rock lining (looking towards sump)

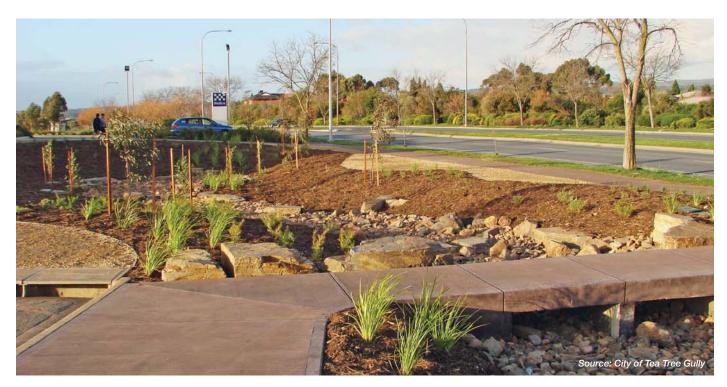
Completed landscaping

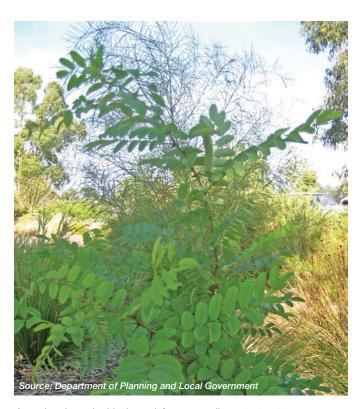
Weed control—Suckering of nearby street trees could become a long-term management issue for this site and the surrounding areas. Selecting plants to grow in the existing site subsoils has helped minimise weed issues.

A sucker (weed with thorns) from an adjacent street tree

- Regularly assess the site for suckering of nearby street trees and remove the shoots before they develop (the rootstock can be a fast-growing weed and have thorns, which are not appropriate for public spaces).
- Allow natural regrowth over time in open areas once weed species are eradicated and remove pioneering plants as more robust, long-lived species mature.

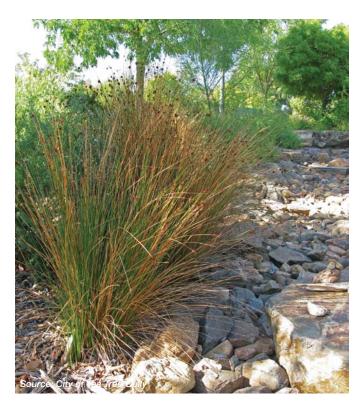
Scientific name	Common name	Observations in February 2010
Isolepis nodosa	Knobby Club-rush	Planted winter 2007 Located on the edge of the swale, these plants are showing some signs of water stress. Pruning back the plants may enable them to increase nutrient uptake and maintain their dark green, reed-like foliage.
Acacia melanoxylon	Blackwood	 Natural succession occurring in the jute mat. Planted winter 2007 Plants are growing well on the mid to upper sides of the swale.
Juncus pallidus	Pale Rush	Planted winter 2007 Plants are growing well on the edge of the swale with natural succession occurring in the jute mat. More planting of this species would be useful to keep debris away from the sump and reduce downstream movement.

Selection of species—More *Juncus pallidus* could have been used around the sump/invert at the base of the swale to reduce litter entering the sump. Two dry seasons have affected the growth of the *Isolepis nodosa*, which may require more regular flood events.

Isolepis nodosa, showing signs of water stress, on the edge of the swale

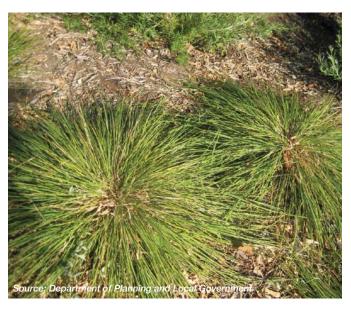
Vegetation—Overall, the plants on the site are growing well, with only the *Isolepis nodosa* and *Lomandra 'Katrinus'* showing signs of water and heat stress.

Lomandra 'Katrinus' in general landscaping showing signs of a lack of water and heat stress

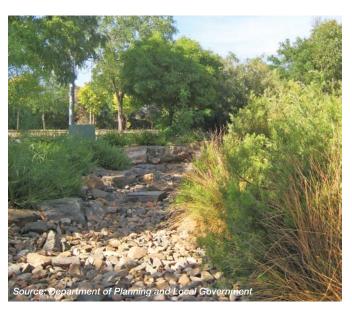
Condition of the detention swale in February 2010

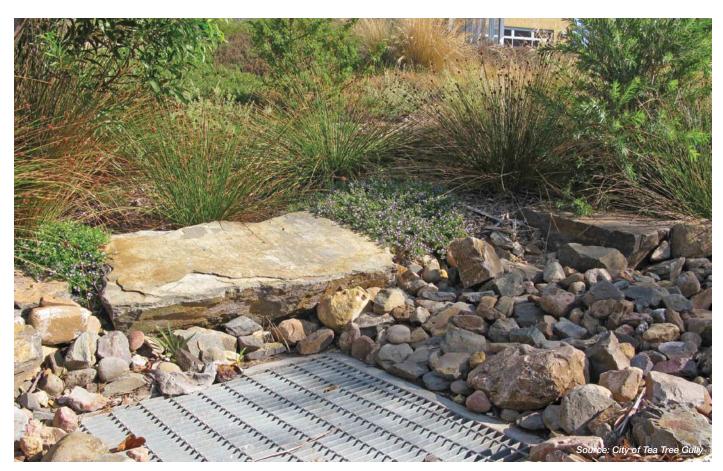
Sump outlet showing well established plantings of Isolepis nodosa

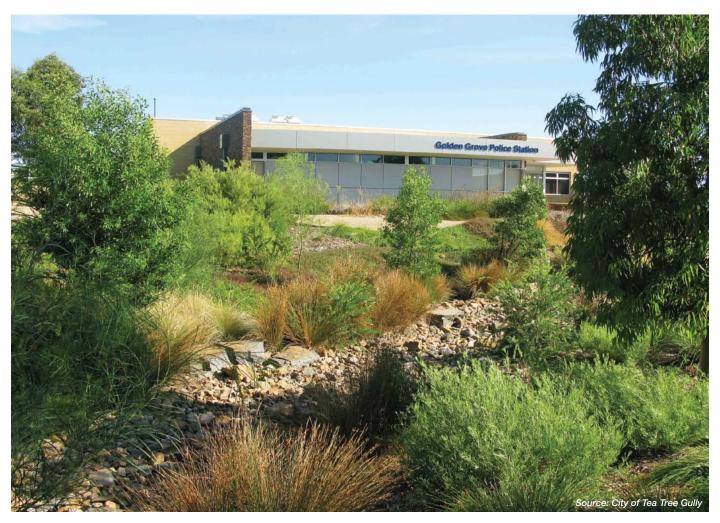
The state of the site after two growing seasons; Plants growing well on the site, with only Isolepis nodosa and Lomandra 'Katrinus' showing signs of water and heat stress
