Maintenance and renewal of permeable paving assets

City of Charles Sturt

History of permeable paving in CCS

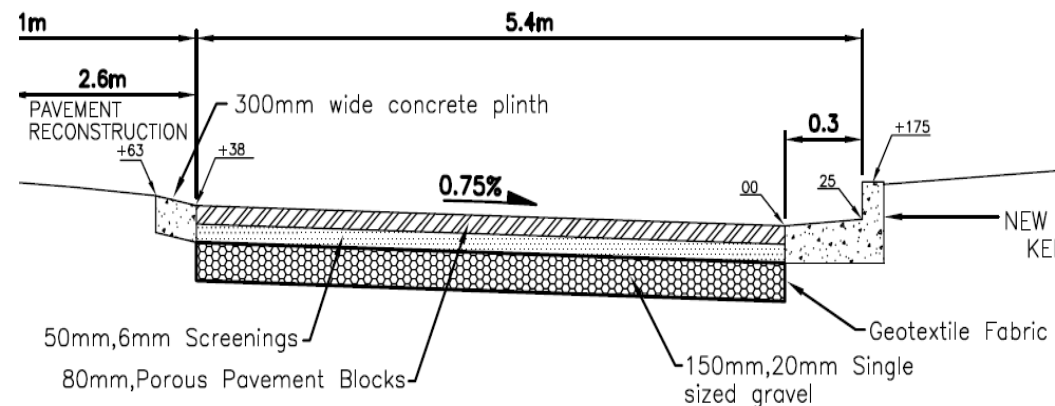
TYPICAL CROSS SECTION (N.T.S.)

- Kirkcaldy Avenue, Grange
- Constructed in 1999 – one of our earliest systems.
- Intent – reduce gutter flow width and ponding in the roadway in smaller rain events
- Design – falls away from road to hold about 40mm of water
- 80mm Boral Hydrapave

- Swept 5 times a year
- Issues
 - Some decrease in performance – water holds then slowly soaks away
 - Serviceability issue with the ponding water – no complaints received
- Remedial action
 - High pressure clean – Approximately \$1000
- Continue to monitor as no significant impact

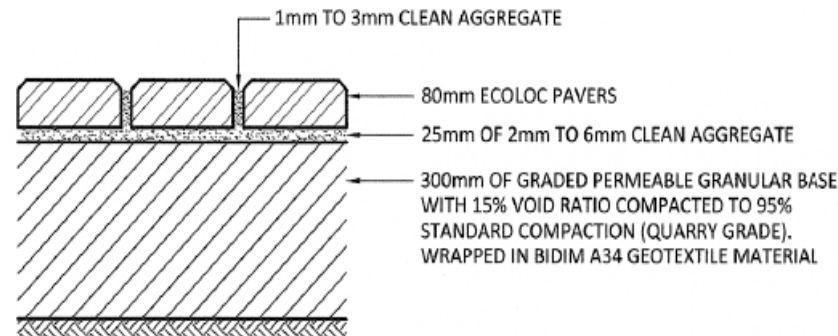
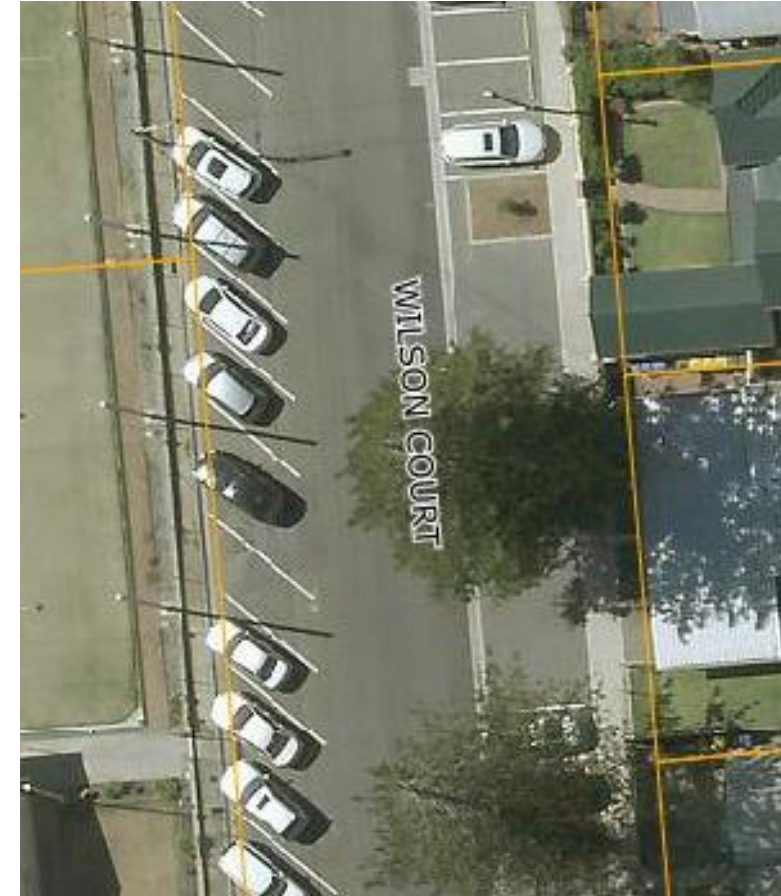
Wilson Court Parking Bays

- Wilson Court, Grange
- Constructed in 2012/13FY
- Intent – prevent ponding due to leaf litter blockages from mature Norfolk pines.
- Design
 - change parking bays to outfall away from trees
 - 80mm Ecoloc permeable paving to ensure trees still received some road runoff

- Swept 5 times a year with additional reactive cleaning as requested
- Issues
 - difficult to do a thorough clean due to high carpark use
 - moss & pine needles blocking gaps

- Remedial action
 - High pressure clean – 2 days labour – approx. \$2000
 - Added to our “carpark” mini-sweeping program (should have been from the start) – no operational asset handover
- Further actions
 - Continue to monitor
 - May need some refurbishment (lift & relay of small sections)

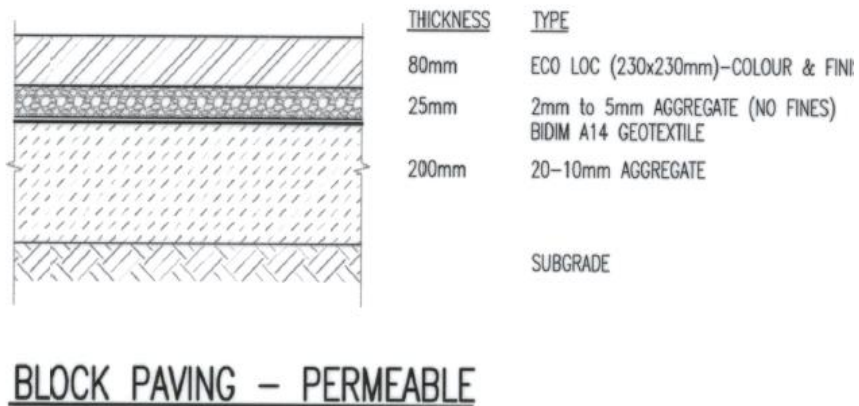
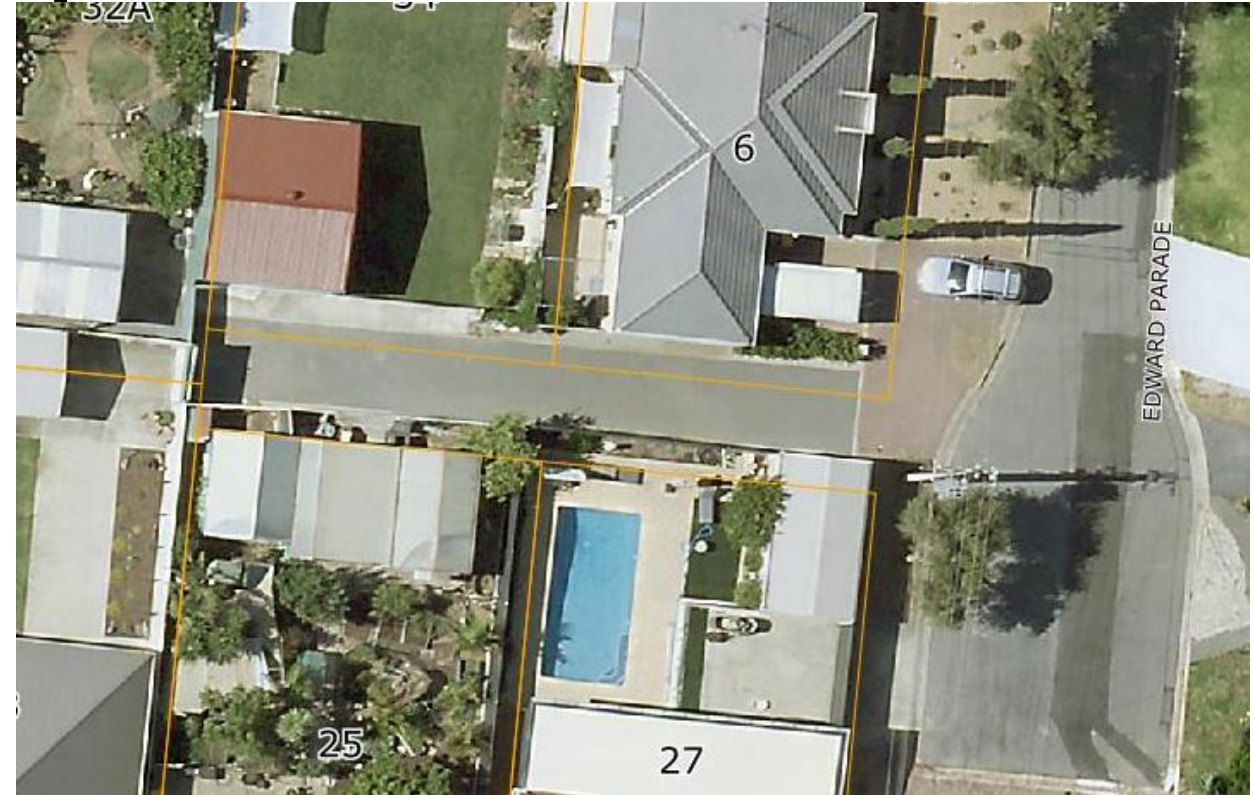
- Duke Lane, Semaphore Park
- Constructed in 2010
- Intent – provide drainage via soakage
- 80mm Ecoloc pavers

- Currently not maintained
- No reported issues
- Remedial action – added to sweeper program

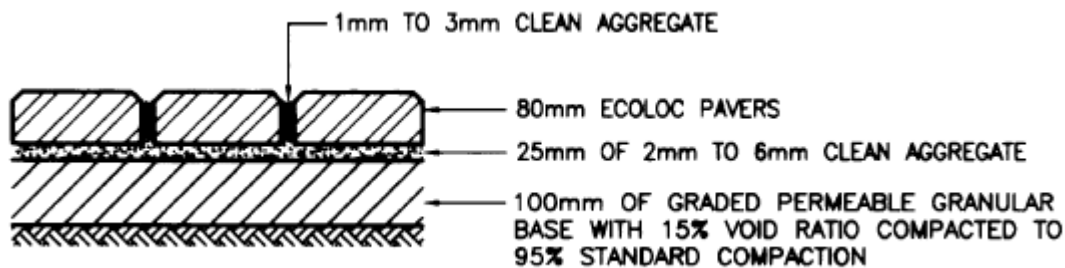
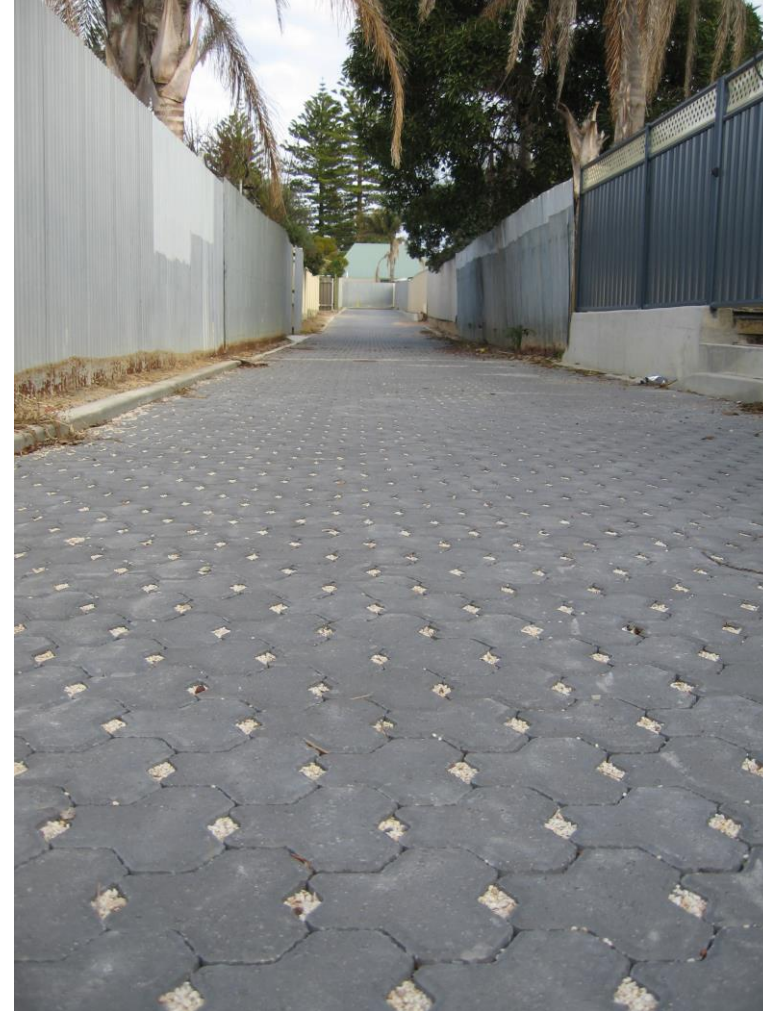
Lane 30 (Anthony St Lane)

- Behind Anthony Street, Henley Beach
- Constructed in 2010
- Intent – provide drainage via soakage to prevent flooding of properties at existing low point
- 80mm Ecoloc pavers

- Swept every 6 months
- Resident complaint - mid 2018
 - water not draining due to tree debris and moss blocking gaps
 - ponding significantly and entering property
- Investigation after a rain event confirmed the issue was the gap between pavers was blocked

- Remedial action
- Lift and relay 80m² pavers at low point including replacement of the top geofabric and surface screenings – undertaken in late 2018/early 2019
- Some branches from overhanging tree were also trimmed (tree has since been removed by owner)
- Cost – \$8000
- Continue to monitor after rain events

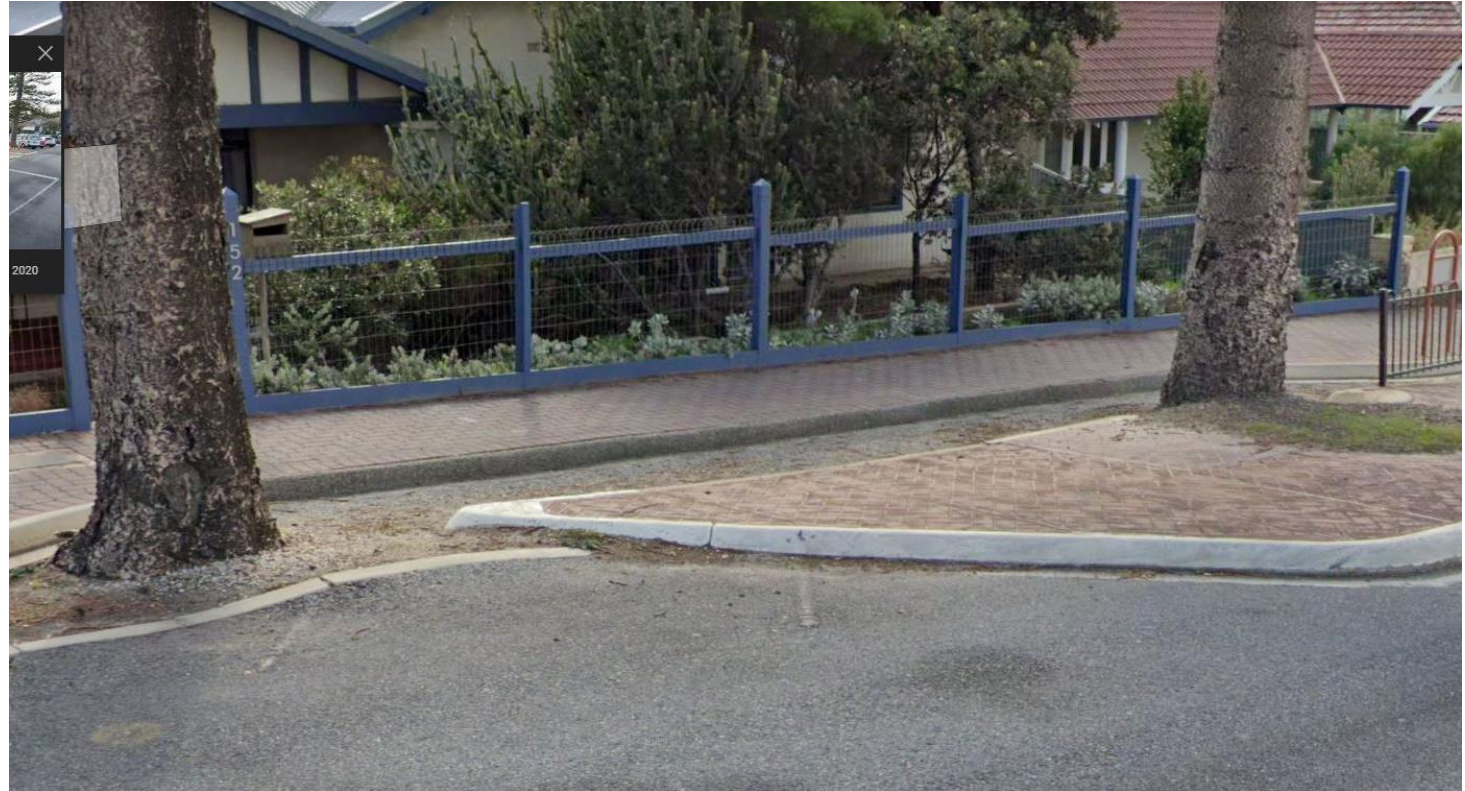
Marlborough St

- Marlborough St, Henley Beach (between Seaview & Military)
- Constructed in 2009
- Intent – reduce gutter flow widths at Emu crossing
- Permeable (no fines) kerb along length behind protrubance

- Maintenance regime - none
- Issues – minimal, leaf litter usually clears itself due to runoff volume and grade. Has reduced gutter flow widths from 3m to 1m
- Remedial action - none

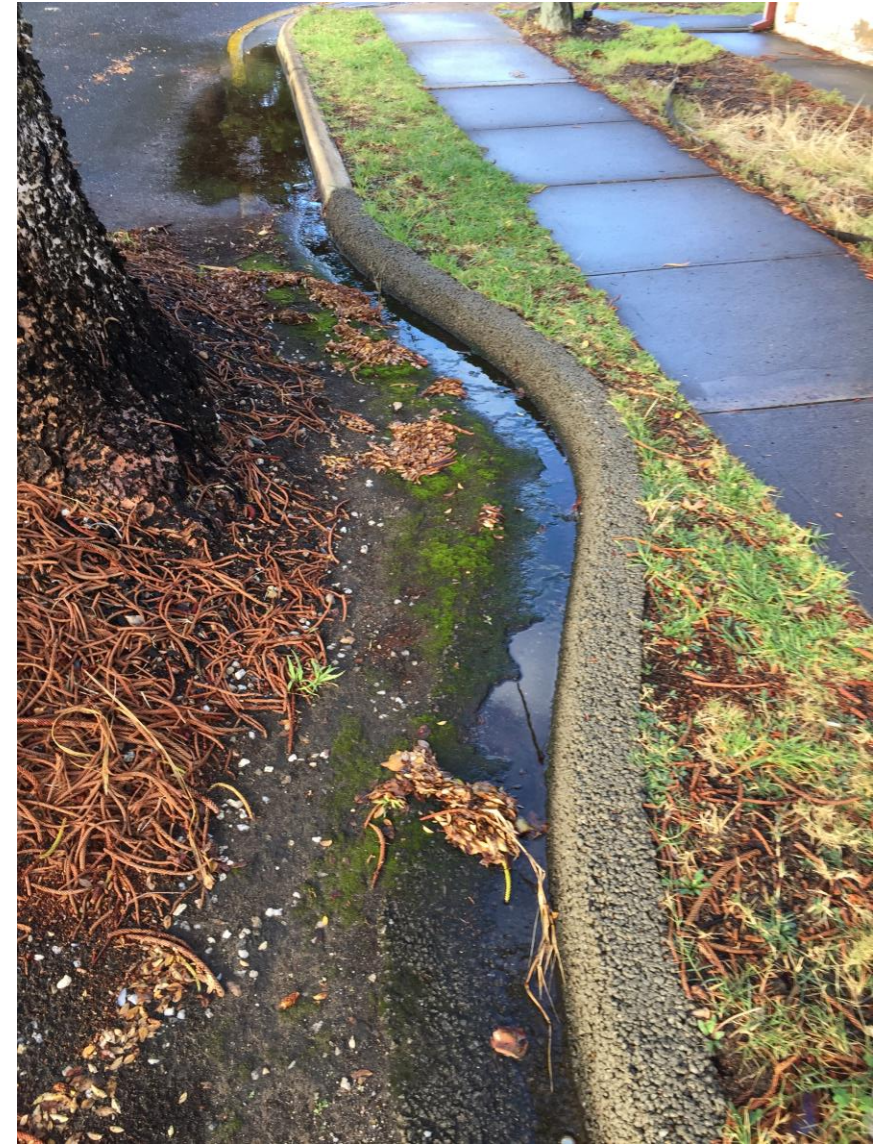
East Terrace

- East Terrace, Henley Beach
- Constructed in 2009
- Intent – reduce gutter flow widths and nuisance ponding
- Permeable (no fines) kerb installed adjacent trees

- Swept 5 times a year & high leaf area reactive
- Issues
 - permeable kerb gets blocked due to fine leaf litter
 - leaf litter and lifted sections prevents water reaching the permeable kerb

- Remedial actions
 - high pressure clean
 - 1 days labour – approx. \$1000 work
- Further action
 - 21/22FY - Replace lifted sections and undertake trial to extend permeable kerb to length of parking bays
 - Expected cost - \$10000
