## Case study – Randolph Avenue streetscape upgrade (Fullarton)

This is one of a series of case studies aimed at demonstrating the range of WSUD solutions being applied by practitioners in SA

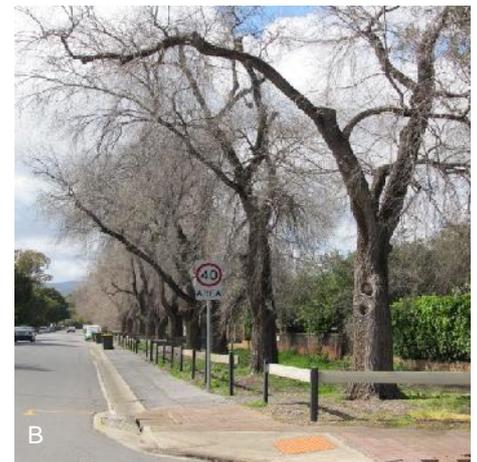
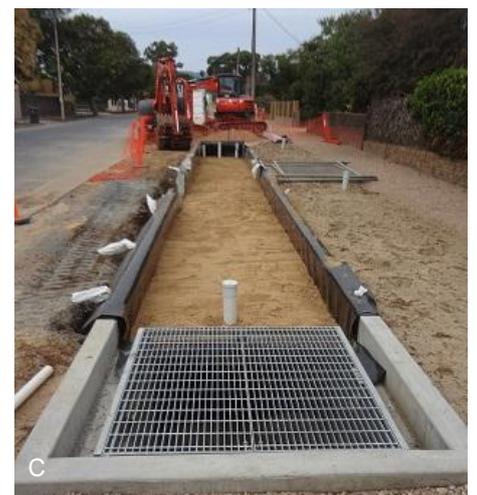
A. Streetscape upgrade and raingardens, January 2016

B. Prior to construction. Source: City of Unley

C. During construction, April 2015

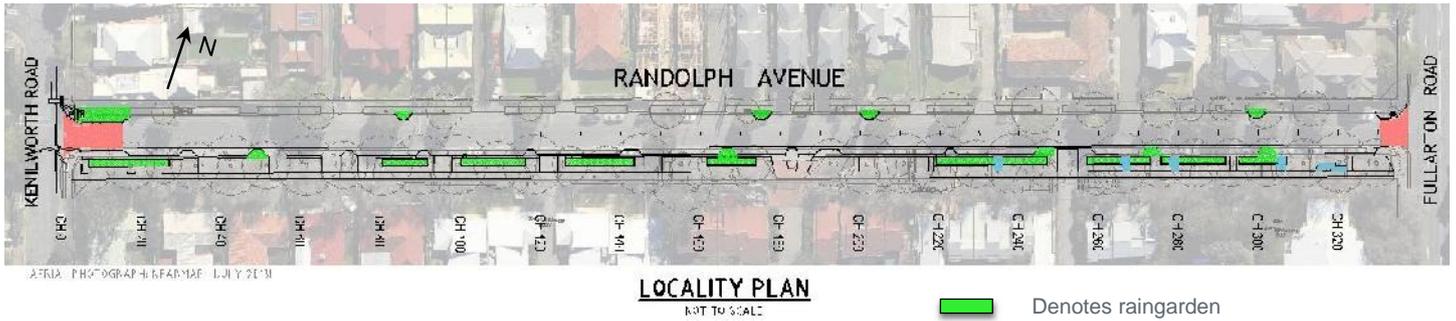
Plan view of Randolph Avenue raingarden locations

- 10 raingardens of dimensions 1.70-2.10m wide with a variety of lengths ranging from 6.75-25.5m)
- Total length of raingarden is 146m giving a total treatment area of 245m<sup>2</sup> (0.5% of impervious contributing catchment)
- A saturated zone of 450mm depth to assist plant viability and storage capacity
- A design infiltration rate of 160mm/hr through filter media
- HDPE lined system with no exfiltration

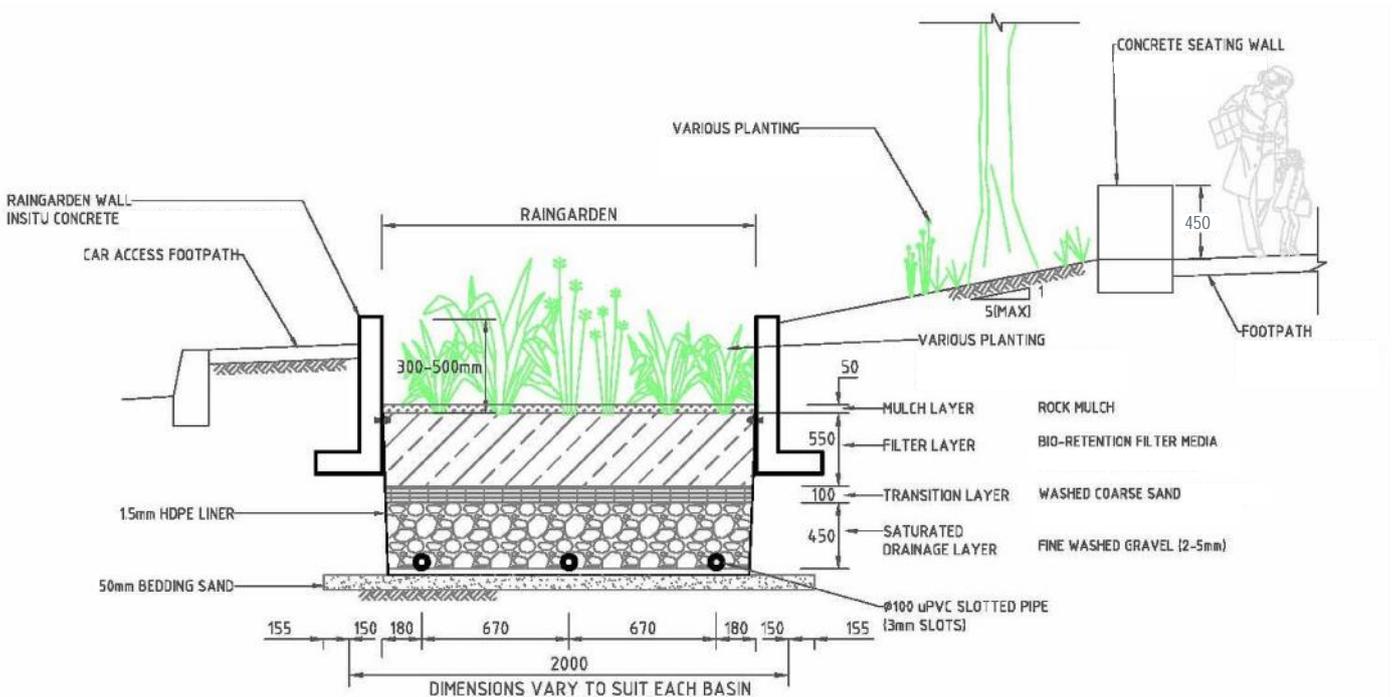
Raingarden typical section

Dimensions in mm

Outlets have been designed to provide between 100mm and 200mm extended detention. The raingardens typically include three inspection and flushing pipes. Treated stormwater collected by the raingarden underdrains (100mm slotted PVC pipe), overflows to a new dedicated 'collector' drain that distributes this filtered water to a number of soak wells located adjacent to the new street trees. Any subsequent overflow discharges to the existing downstream drainage system and ultimately to Glen Osmond Creek.

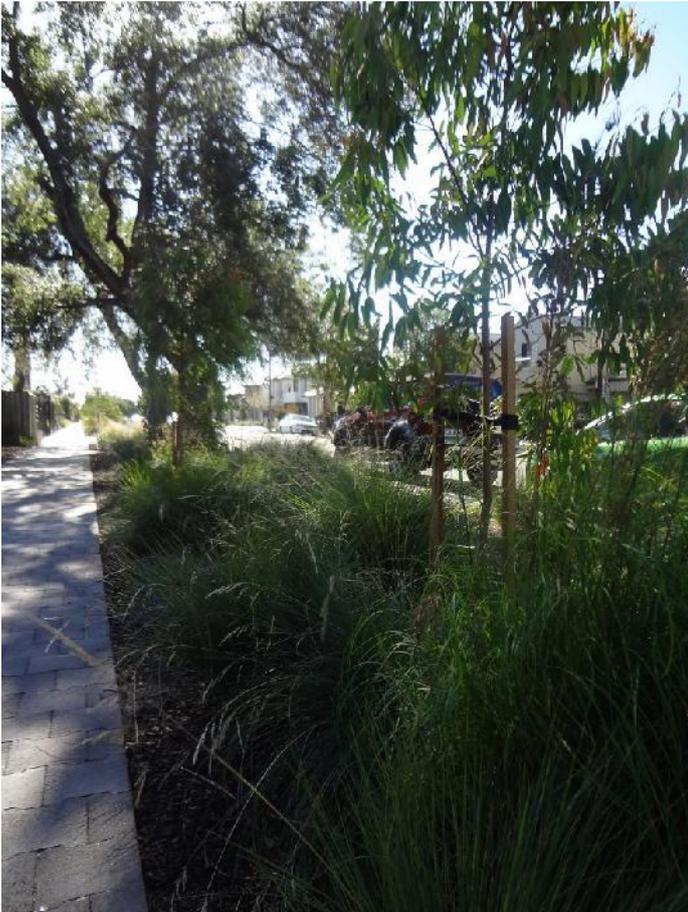
Streetscape trees and understorey supported by stormwater runoff via infiltration wells and shade of existing tree, January 2016

- 31 infiltration wells of dimensions 600x400x450 mm deep
- Waterproof membrane top and bottom with geofabric and 20mm screenings around the perimeter, providing lateral infiltration to adjacent trees and garden beds.

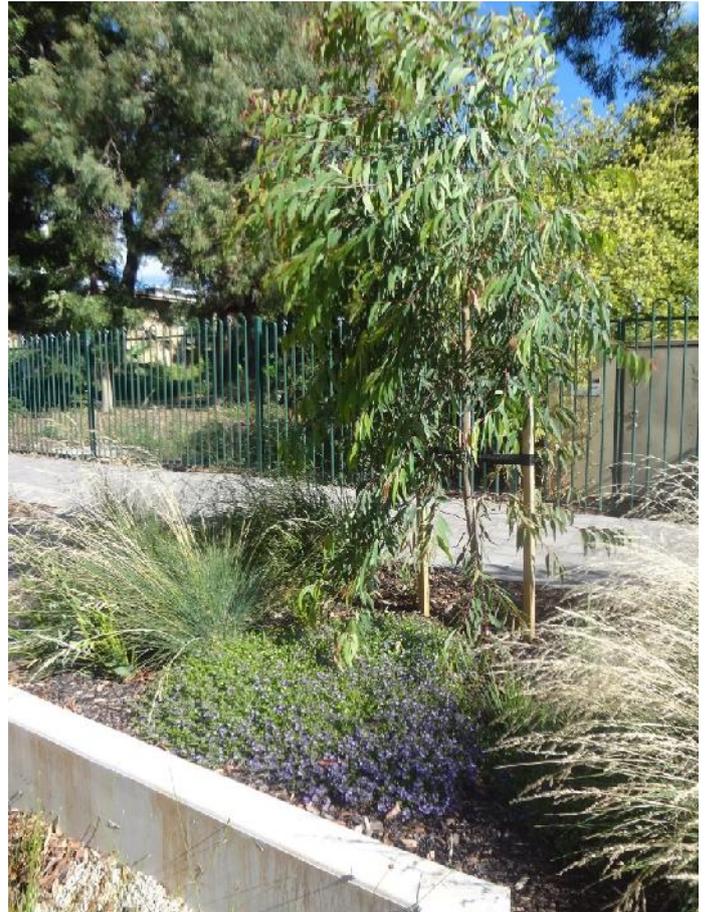
Street trees and understorey supported by stormwater runoff via infiltration wells, January 2016
