## Characterisation of sediments in urban catchments found in infiltration systems – Kingswood case study

Harsha Sapdhare PhD – Research and Development Manager Baden Myers PhD – Research Fellow, University of South Australia David Lawry OAM – Director, Space Down Under <u>harsha@spacedownunder.com.au</u> <u>https://www.spacedownunder.com.au/</u>

### Case study site: Eynesbury Ave, Mitcham, South Australia

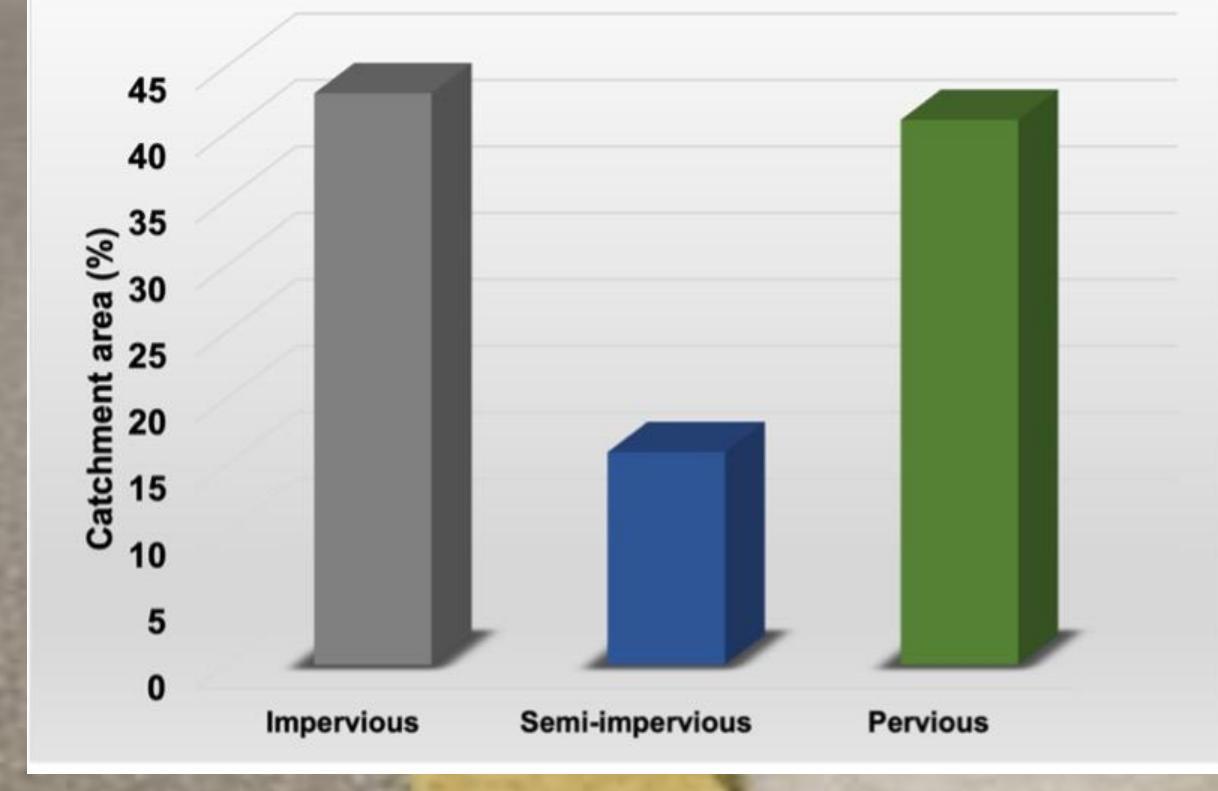
### **Catchment characteristics**

Study catchment area – 2.7 ha. The longitudinal slopes 1 to 1.4 % Pervious area – roofs, roads Semi-impervious area – driveways, footpaths, other paved areas

Pervious area – nature strips, vegetated and non-vegetated areas

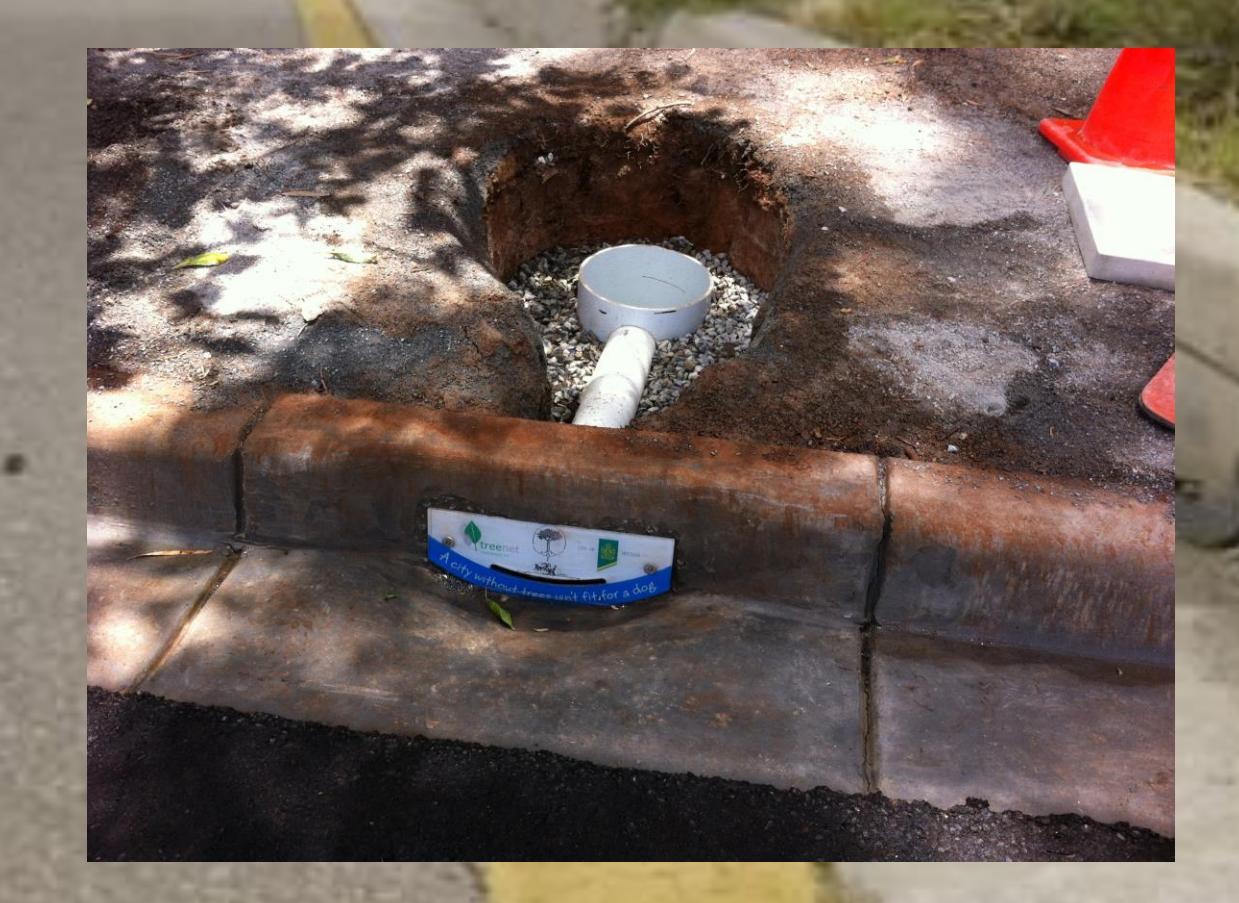
# Leaky wells – Infiltration zone

Total 28 TREENET inlets with infiltration systems (leaky wells)
Filter media

Gravel x 7
Water treatment solids x 7 (SPACE)

Sandy loam x 7Clay x 7

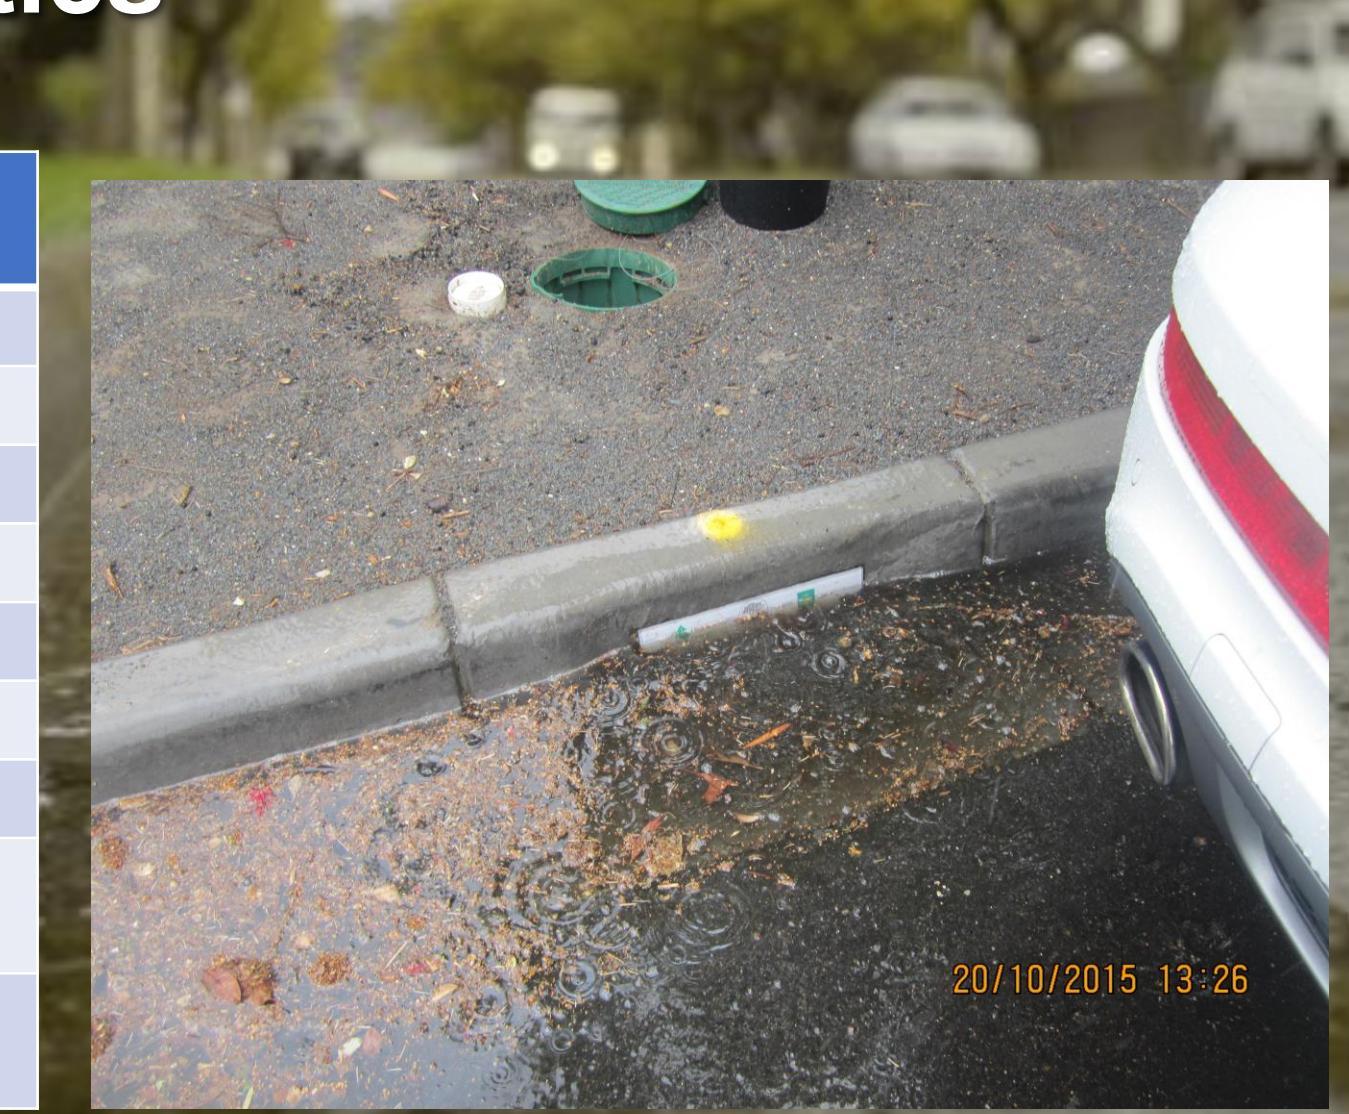
### **Chemical characteristics**

Heavy metals	Contaminants mg/kg ± SD
Arsenic	7.25 ± 3.34
Chromium	13.75 ± 3.41
Copper	20.5 ± 9.60
Lead	22 ± 11.76
Manganese	176 ± 82.44
Nickel	7.5 ± 2.06
Zinc	51.25 ± 5.06
Total petroleum	940 ± 171.46
hydrocarbons	
Organophosphorus pesticide	$101.05 \pm 6.43$
surrogate

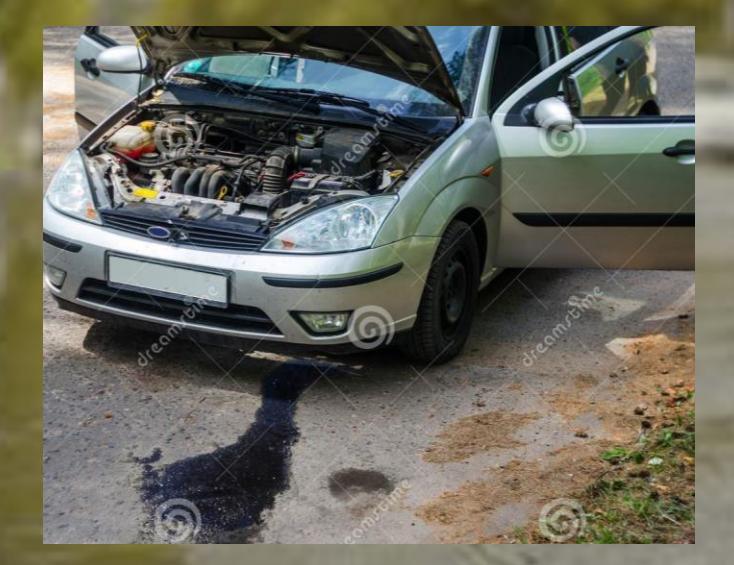
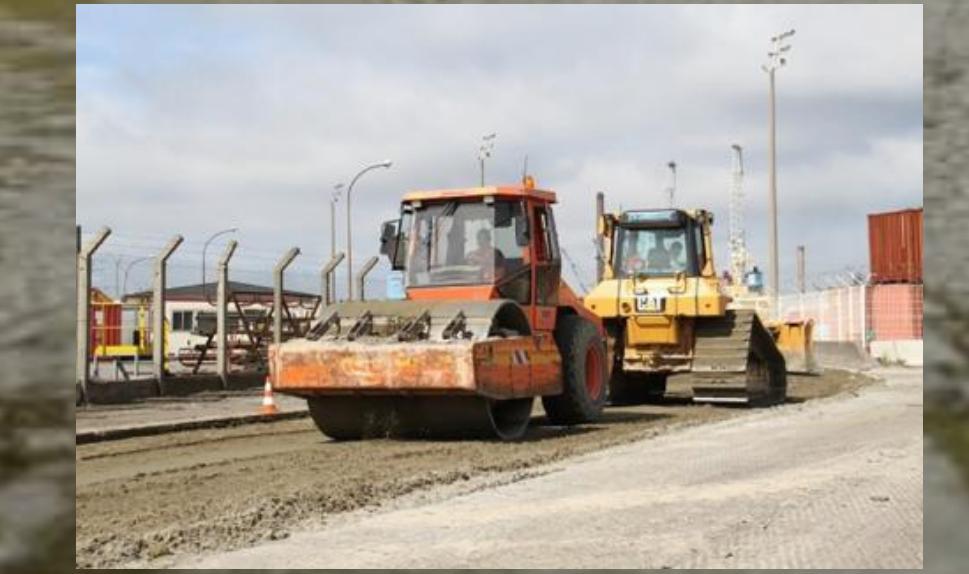
### **Source of sediments**

Source	EMC, mg/L
Bare ground	736
Car park	64
Commercial	61
Construction site	1200
Grass	40
Road	229
Roof	16.3

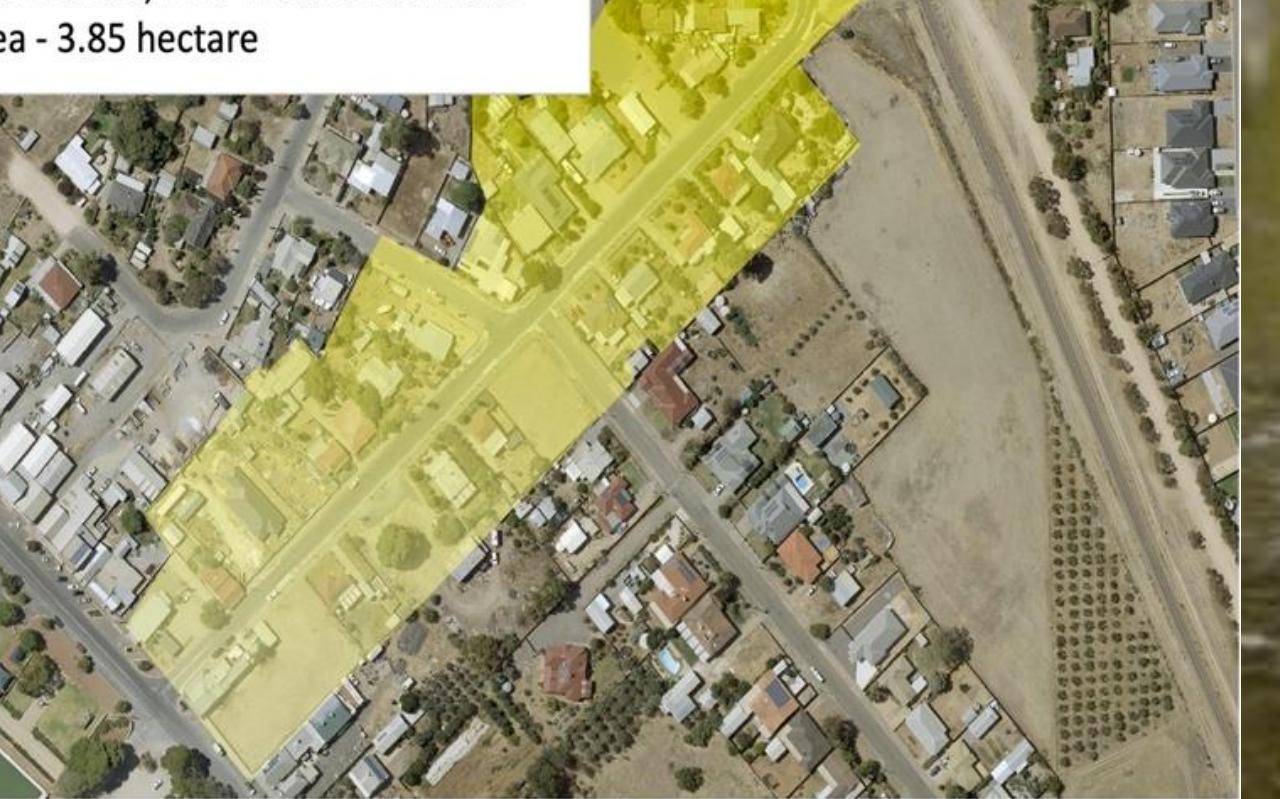
Drew Street, Two Wells Catchment Area - 3.85 hectare

a. Catchment area – 3.85 hectare b. Capture zone – 5 \* R750 double slots (TREENET inlets) c. Infiltration zone – 5\* R275 L (Trench) d. Installation date –July 2021 e. Tree species – Golden rain trees (koelreuteria paniculate) f. Soil Type – Sandy loam

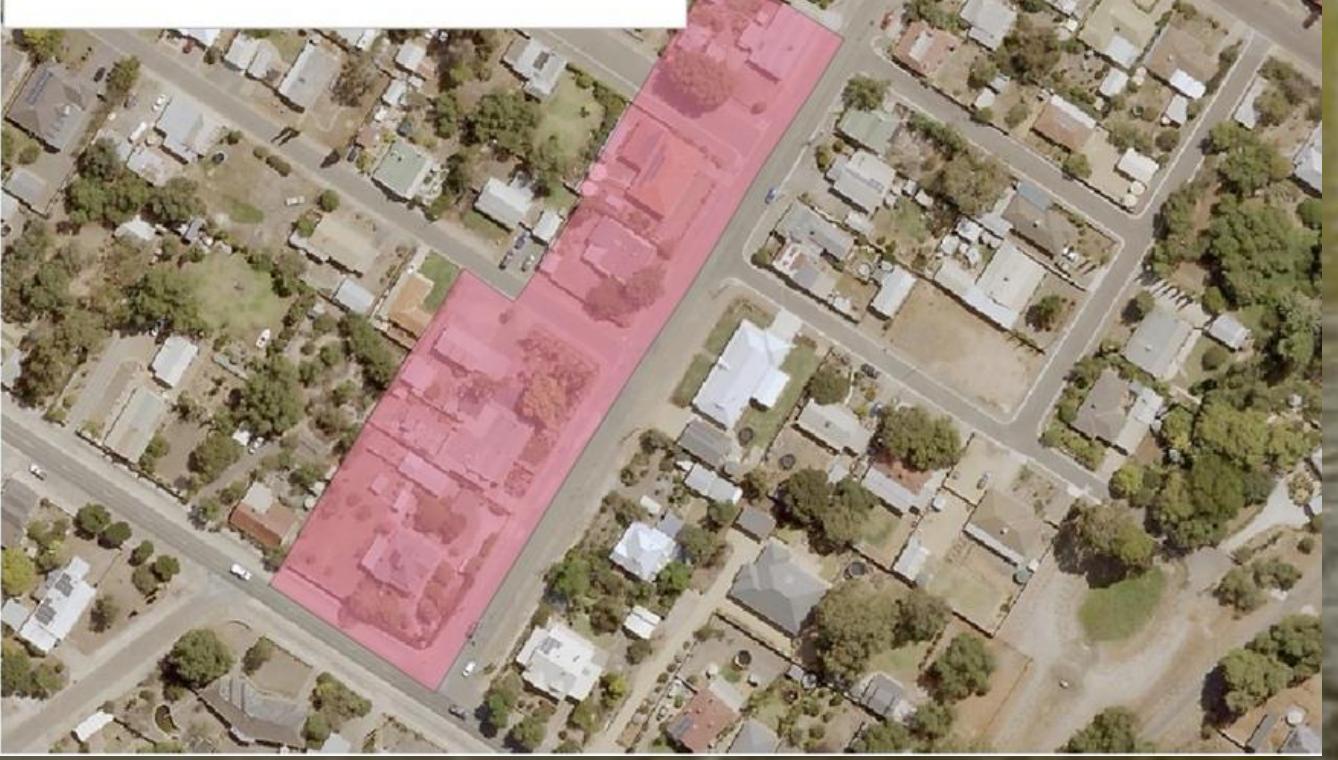
Hare Street, Kapunda Catchment Area - 1 hectare

a. Catchment area – 1 hectare
b. Capture zone – 5 \* R750 double slots (TREENET inlets)
c. Infiltration zone – 5 \* R275 L (Trench)
d. Installation date – July 2021
e. Tree species – Cupaniopsis anacardioides (Tuckeroo)
f. Soil Type – Medium clay

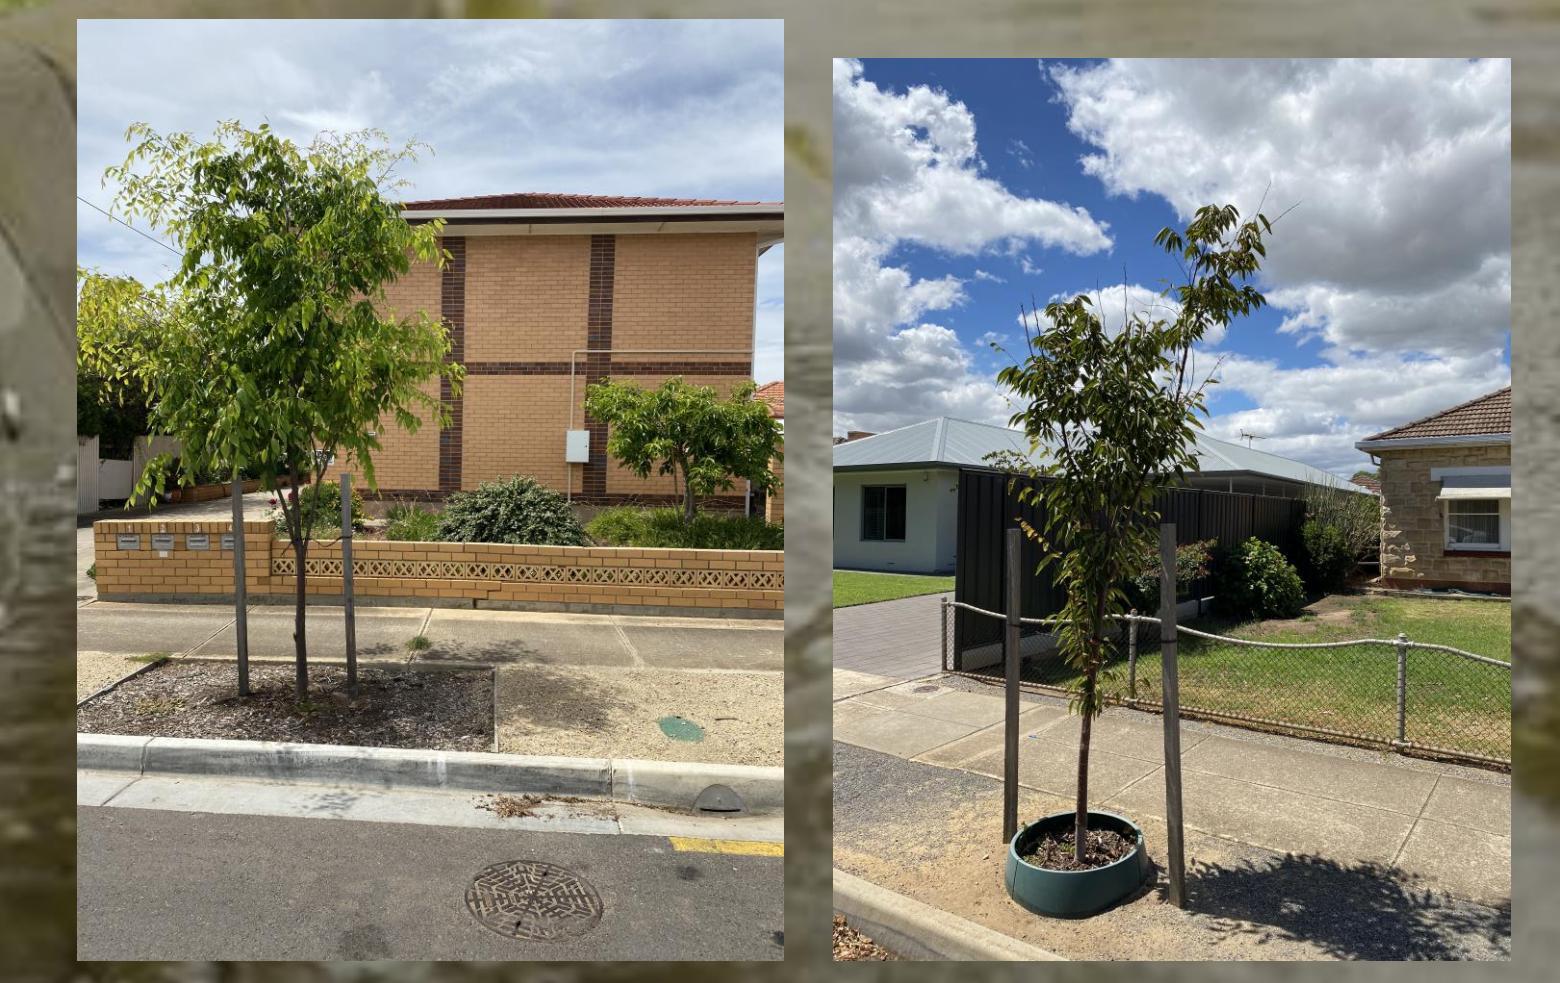
- 4.19 ha catchment area
- Urban residential street
- Soil type sandy clay
- Tree Species Japanese elm (Zelkova serrata)
- 25 Trees with inlets
- 26 Trees with drip irrigation
- 4 Trees with control irrigation

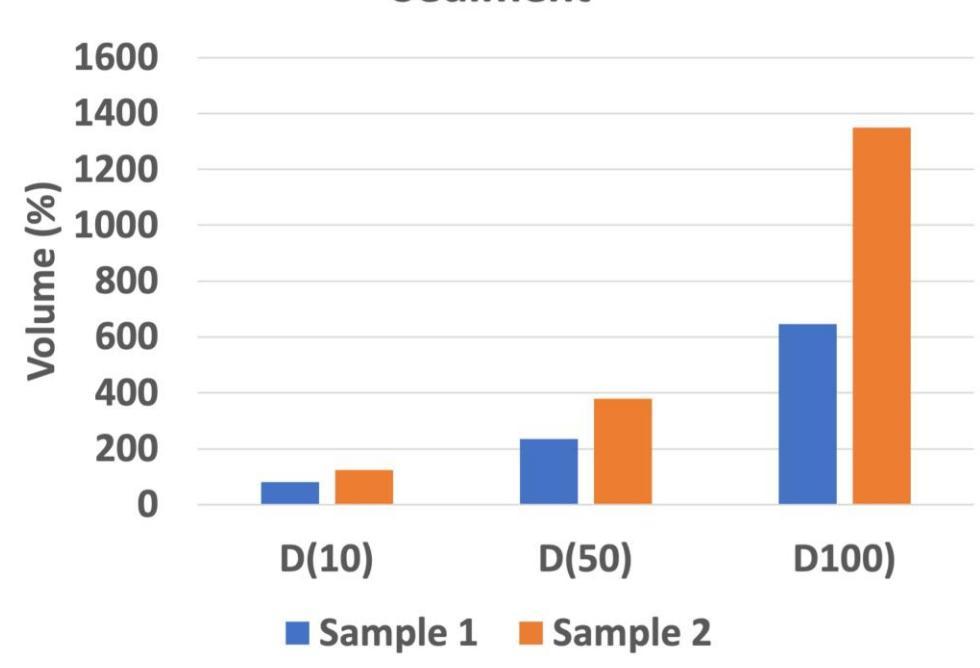
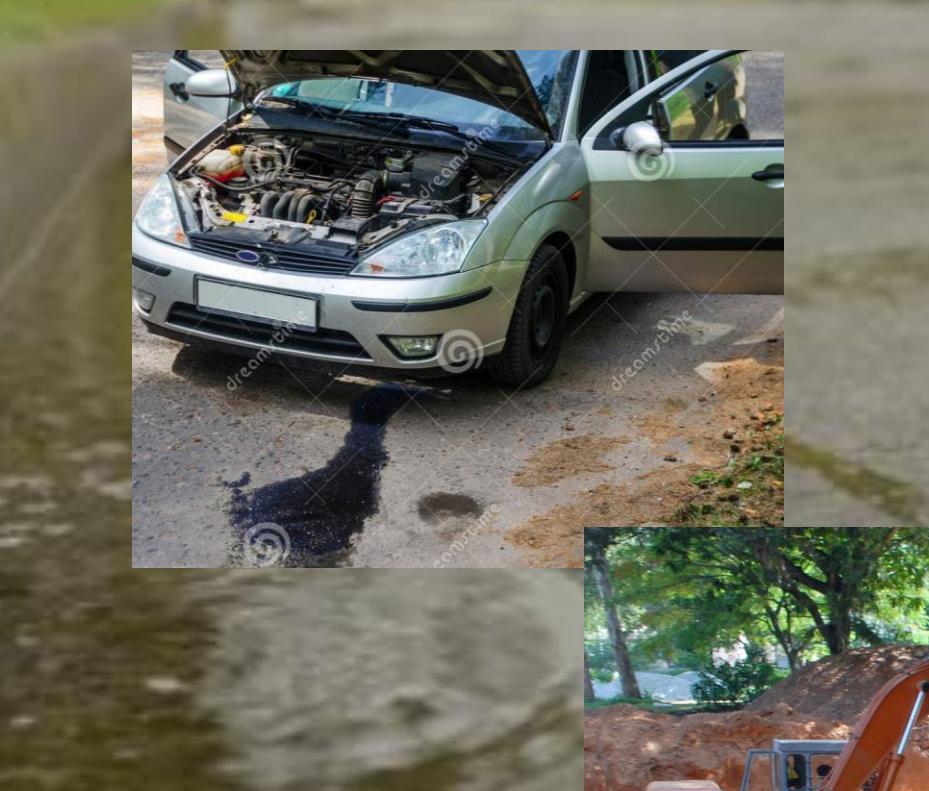
### **Particle size distribution**

Sediment
